Case 348 : Narrative

Case Vehicle (A): 2002 GMC
Type: Sonoma SLS, extended cab pickup 4x4
Driver: 21-year-old male
CDC: 12-FLEE-3, 12-FREE-3

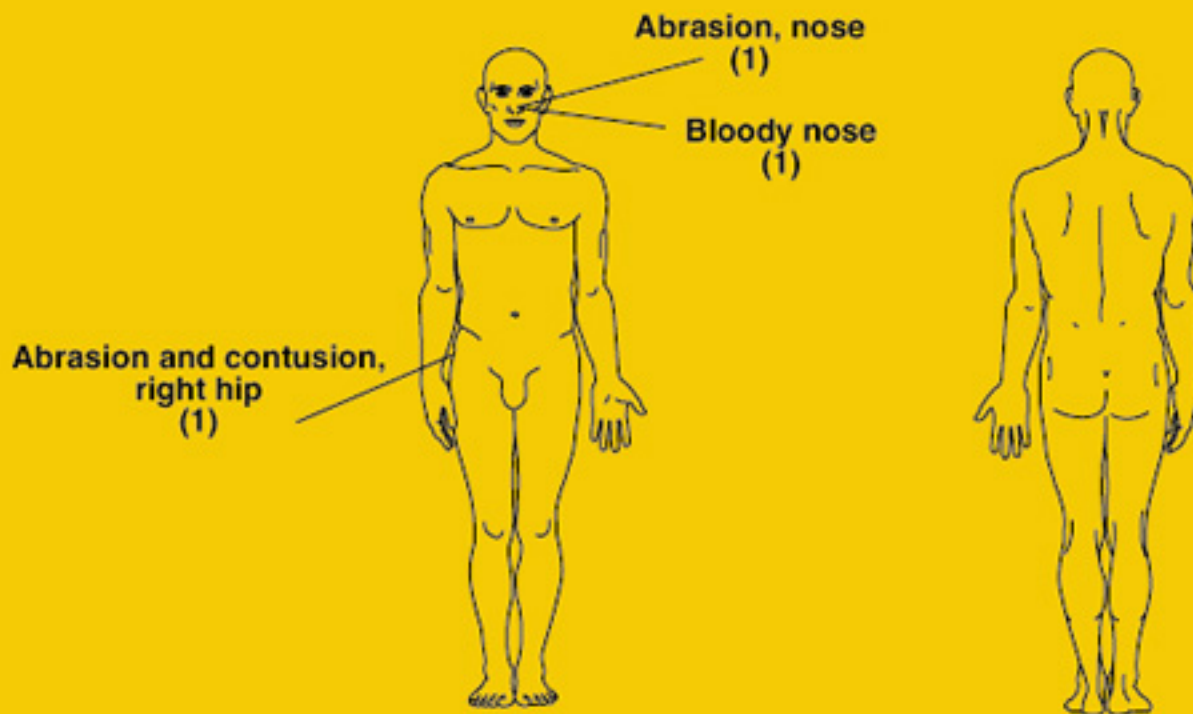
Case No.: 348-02
Case Veh. (A): 2002 GMC
Type: Sonoma SLS, extended cab pickup 4x4
Driver: 21-year-old male

Weather: Clear
Road Surface: Dry
Road Construction: Dirt
Light Condition: Dark/unlighted
